# Data Collation Report

## Teesdale Flood Risk Identification Study

Golden Plains Shire

16 May 2023

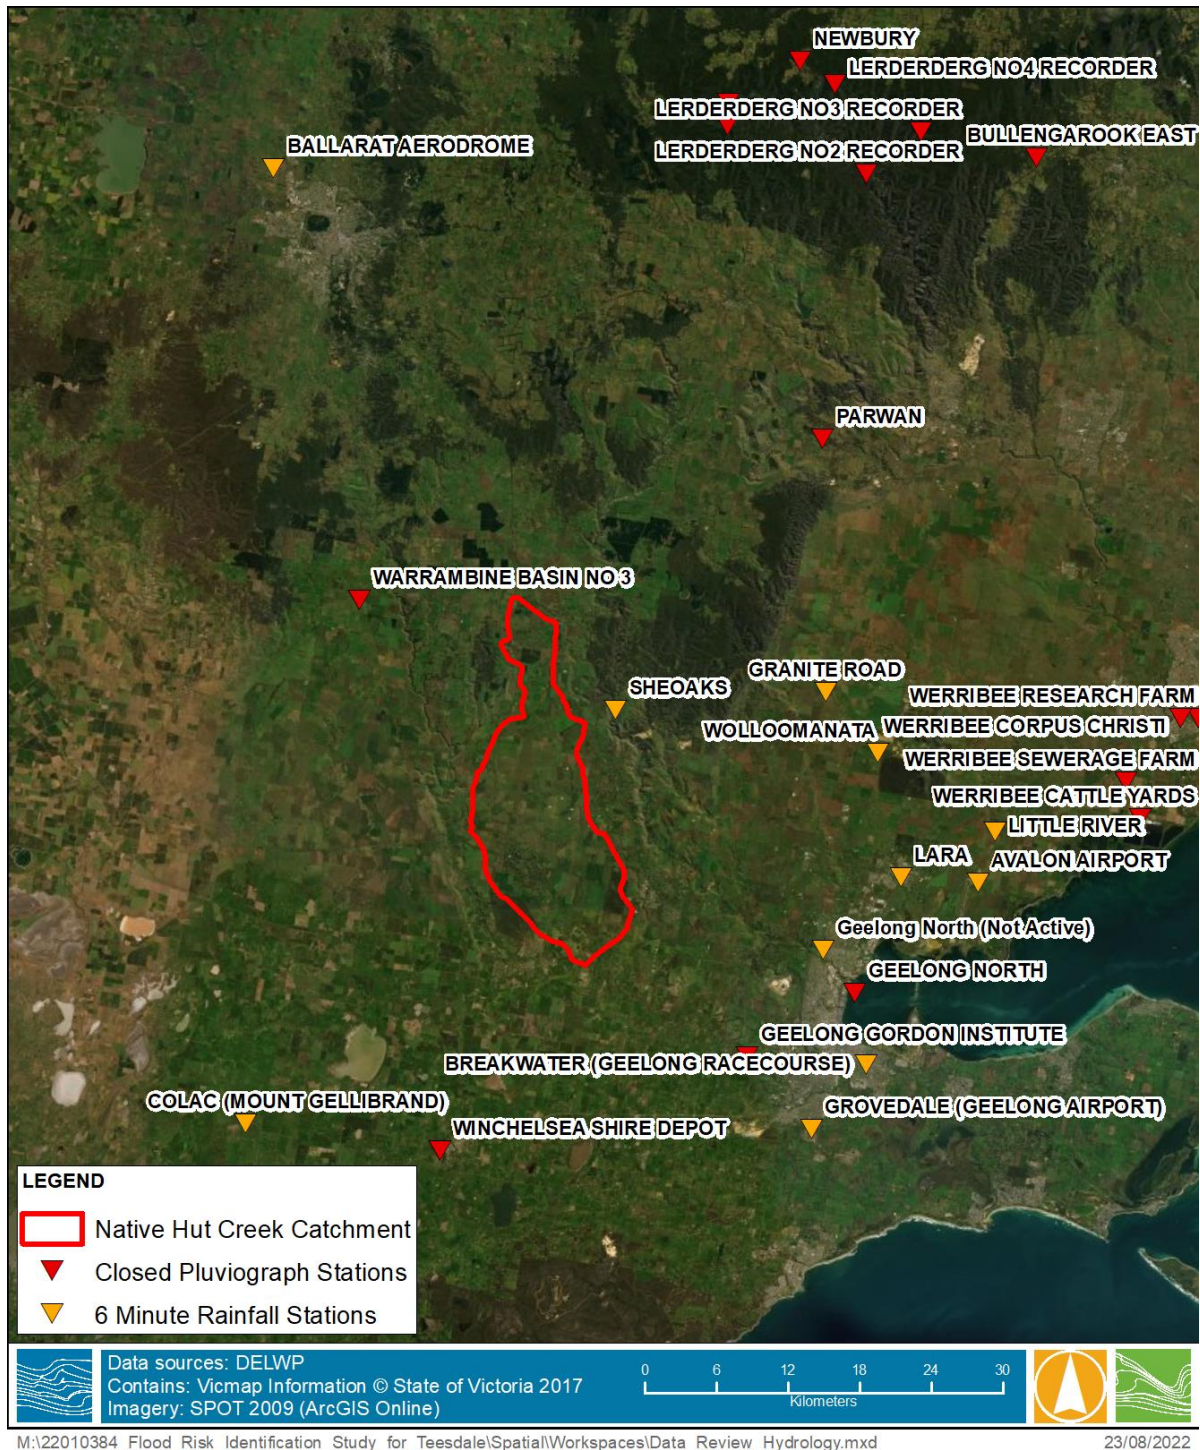
Figure 2-4 Pluviograph stations near Native Hut Creek Catchment

There are no sub-daily rainfall stations within the Native Hut Creek catchment. The locations of nearby current and closed sub-daily rainfall stations are shown in Figure 2-4. The nearest sub-daily catchment is Sheoaks, approximately 14.5 km northeast of Teesdale. Multiple sub-daily stations are available to the east of the catchment in more populated areas near Geelong and Lara, while to the west of the catchment stations are available at Colac and Ballarat.

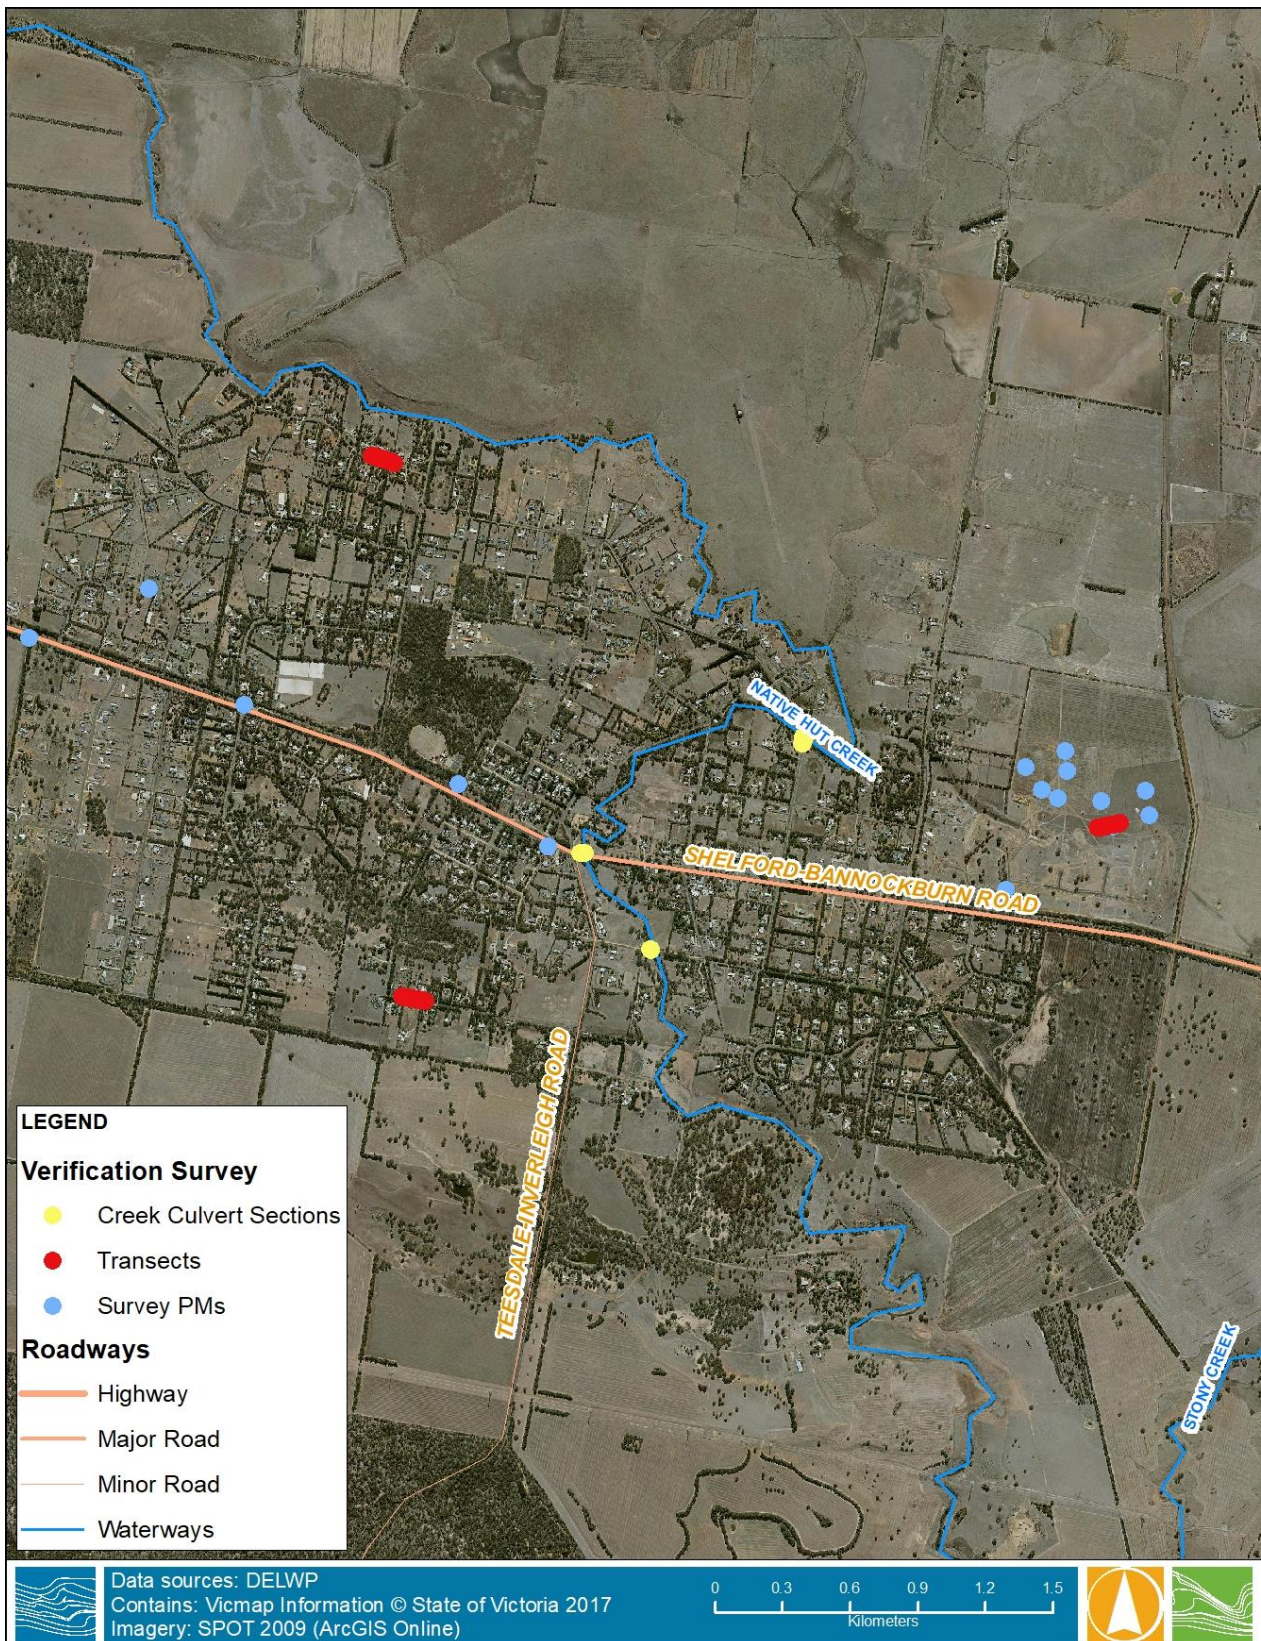
Figure 2-6 Verification Survey

The capture of ground survey at three locations within the study area was commissioned to assist with verification of the available LiDAR datasets (Figure 2-6). The survey consisted of transects along the crest of roadways shown in Figure 2-6. Each transect is approximately 100 m in length with a spot height every 5 metres. The transect results compared with available LiDAR datasets are presented in Table 2-7.

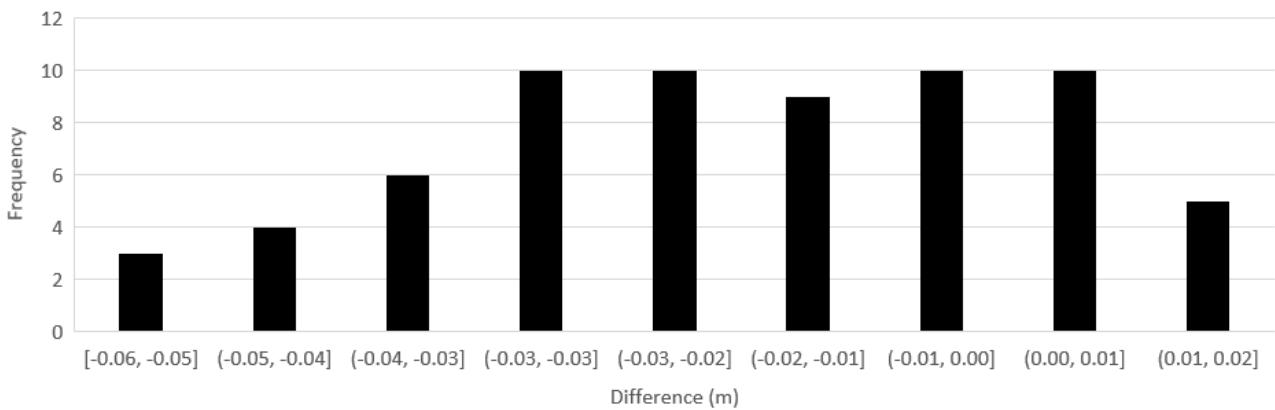
**Figure 2-7 Distribution of survey and LiDAR comparison**

63 surveyed crest points were available across the road transects, each of the surveyed levels was compared to the level determined in the LiDAR data and the difference between the two calculated. The levels were plotted against the survey for the three transects shown in Figure 2-8 – Figure 2-10. Of the 63 points compared, 60 were within 0.05m. The average difference across the three transects is less than 2cm as shown in Figure 2-7 and Table 2-7. This shows a high degree of accuracy and indicates the LiDAR is suitable for use in the development of the Digital Elevation Model (DEM) for the hydraulic model.

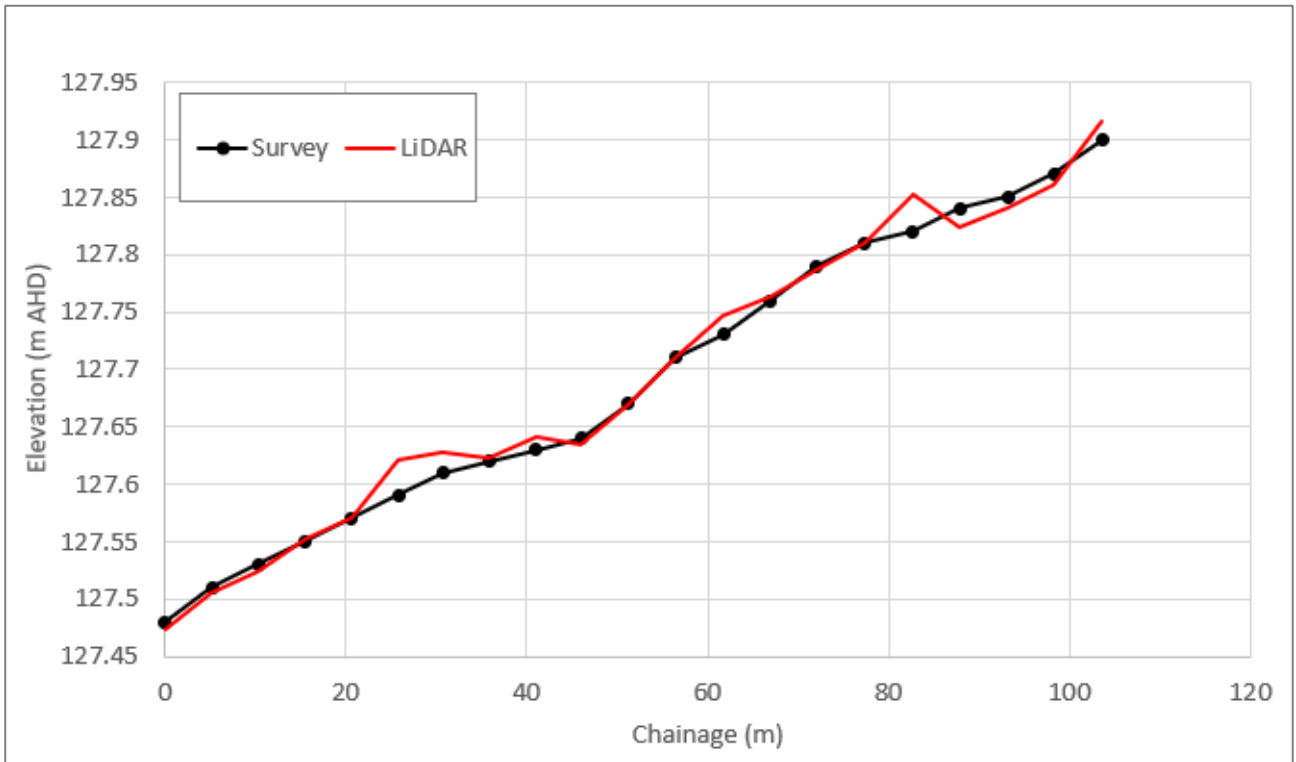
Figure 2-8 Rocklea Road – LiDAR verification

The 2021 Golden Plains LiDAR was verified by comparison to surveyed road transects (captured at three road crossings). Comparison to cross section survey was completed in two ways; on a point by point basis to create a statistical distribution of the differences and as transects to get a visual comparison of the reliability of the data.

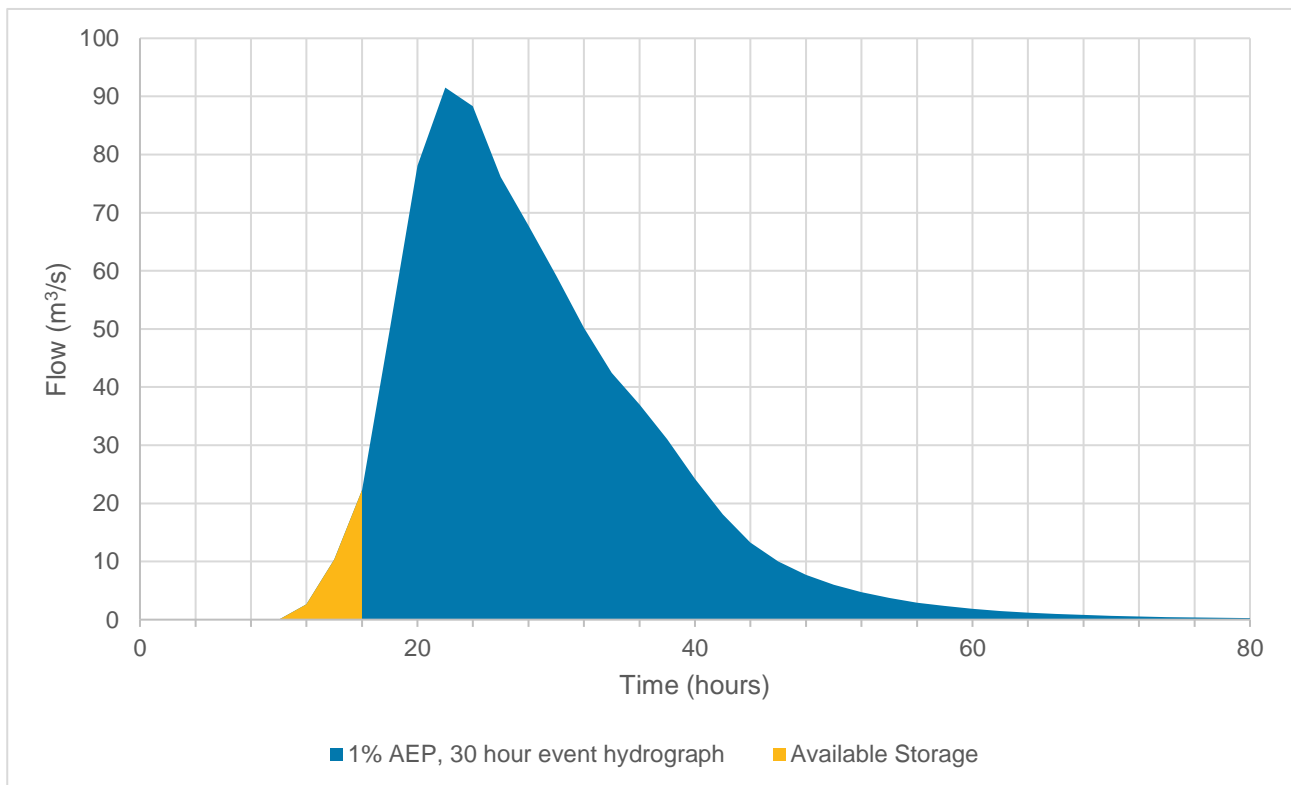
Figure 4-1: Example storage vs hydrograph volume comparison

The potential impact of the two online storages discussed in section 2.3 has been investigated by considering the potential volume provided by the storages and comparing this to the rising limb of design hydrographs in frequent events. An example calculation based on an estimate of available storage in the dams from LiDAR and the design hydrograph output for a 1% AEP event from the CCMA RORB model is presented in Figure 4-1 below. This highlights the minimal storage available when compared to the overall hydrograph volume and indicates there is likely to be minimal impact whether the dams are full or empty at the time of a large flood event.

In minor events the storage may have an impact on flood behaviour for Teesdale. Design modelling will adopt the conservative approach of assuming the storages are full however this should be considered as part of the broader antecedent conditions.
